RIVAS
SCP0-GA-2010-265754

RIVAS
Railway Induced Vibration Abatement Solutions
Collaborative project

Validation of wheel maintenance measures on the rolling stock for reduced excitation of ground vibration

Deliverable D2.9

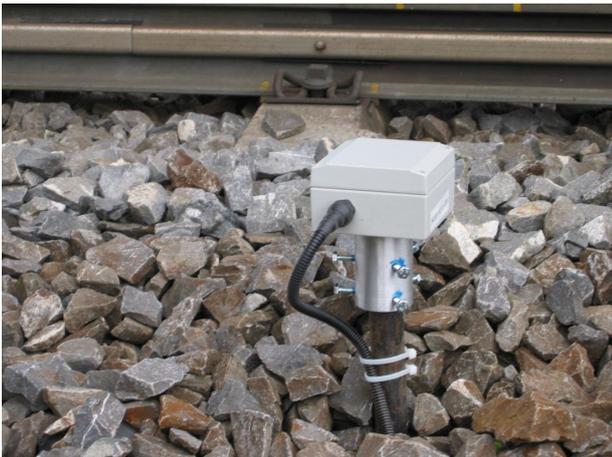
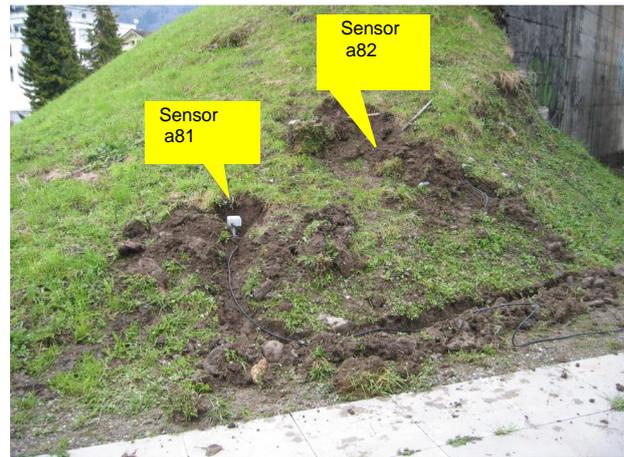
One sensor in the ballast at 2 m distance (50 g measurement range) and the sensors in 8 m distance (10 g measurement range) are shown in Figure 4.7. The anti-aliasing filter at the amplifier was 500 Hz and the signal sampling rate was 10 kHz.

Figure 4.7: Photos of acceleration sensors at 2 m, left photo, and 8 m, right photo.

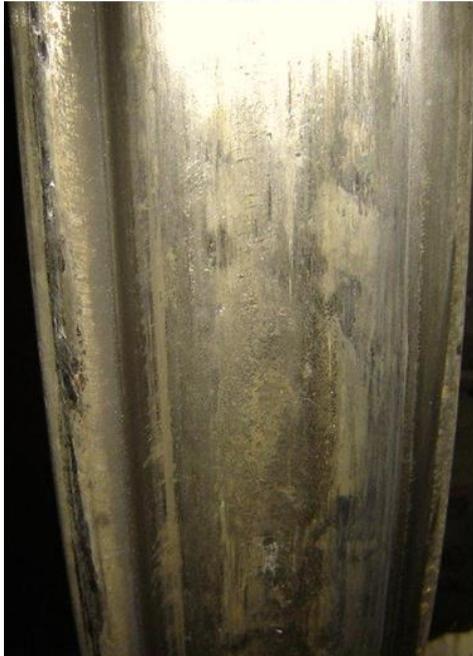
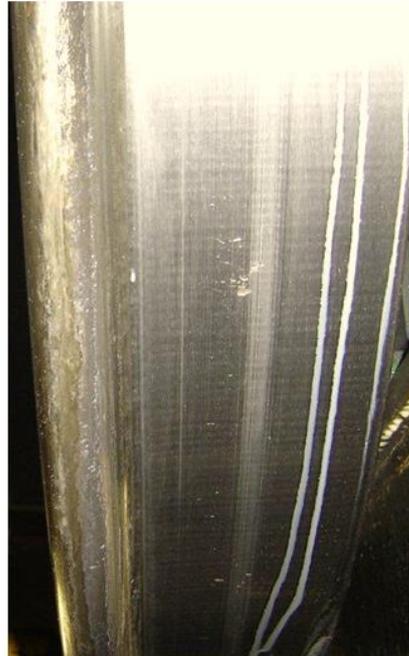
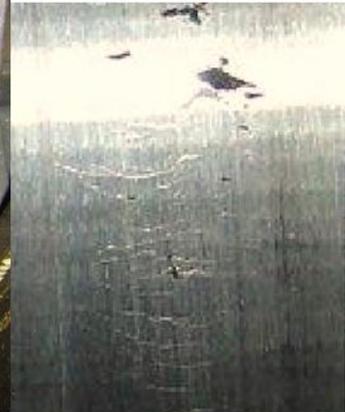
Figures 7.2 and 7.3 show typical RCF faults on wheel treads of locomotives Re420. The faults are located in the running band. The orientation of the cracks (see picture on the right in Figure 7.2) is in the horizontal direction. That means that the mechanism for crack propagation is based on longitudinal creep forces.

Wheel tread before grinding

Wheel tread after grinding

Detail showing crack orientation

Figure 7.2: RCF damage before and after grinding (on the right detail of RCF crack orientation visible after grinding)

Based on test results of SBB a cut of around 6 mm depth (diameter reduction of around 12 mm) is needed to remove the RCF cracks.

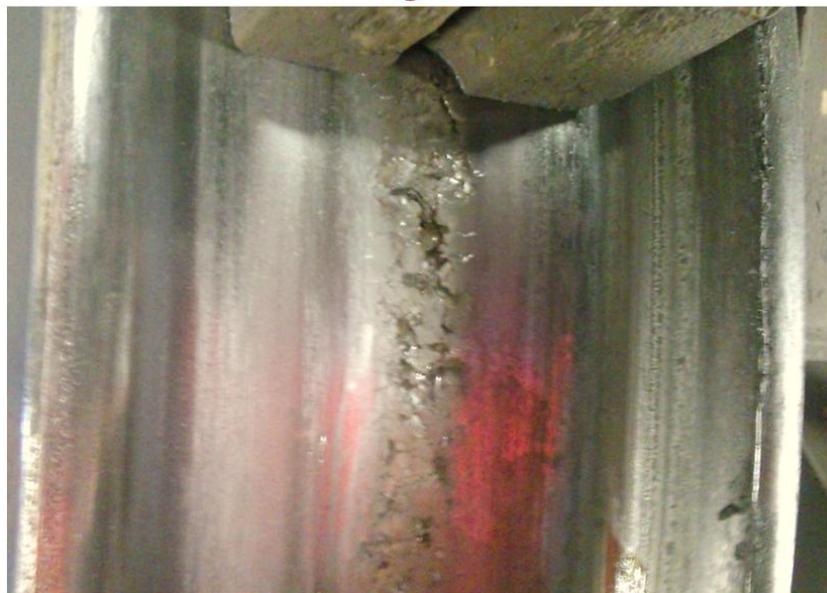
Figure 7.3: RCF in running band of locomotive Re420
